**Flood Control Project Maintenance
Levee Inspections****LMA District Cover Sheet****Spring 2015 Levee Inspection Results****Yolo County Planning Resources and Public Works**

Spring 2015 Levee Inspection Results

Waterway			Bank	Unit Miles
Unit No. 01 Right Bank Cache Creek			Right	0.59
	Spring (March - May)	Summer (June - August)	(September - November) Fall	Winter (December - February)
Unit Maintenance Rating (Fall Only)				
Date of Inspection	04/09/2015 - 04/09/2015			
DWR Inspector	Jai Lor			
Accompanied By

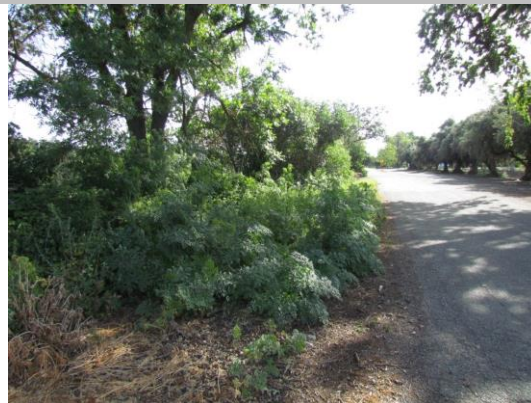
Photo 1 of 1 : SP_2015_NA0021_351_3_20150413_00018.jpg

LM Start	0.03	Rating **	U	Issue No.	3
LM End	0.03	Issue Type +	Ma	Location *	WS
Category	Earthen Levee			GPS Latitude/Longitude	
				Start	End
Item	Vegetation			38.720908 °	38.720908 °
				-121.810398 °	-121.810398 °
DWR ID	DWR_NA0021_01_s_2015_3				
Action/Comments					
Control annual grass and weeds on the levee slopes and easements.

View of vegetation on the waterward side of the levee looking downstream. Spring 2015.

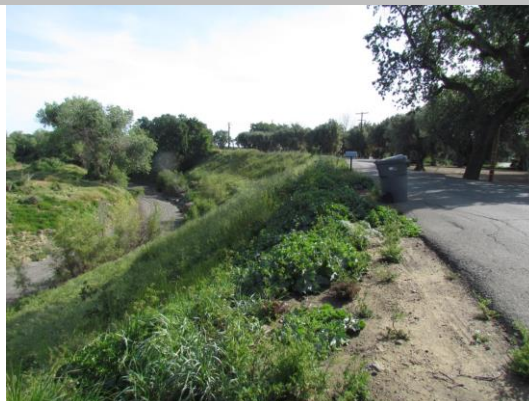
Photo 1 of 1 : SP_2015_NA0021_351_15_20150413_00019.jpg

LM Start	0.14	Rating **	M	Issue No.	15	
LM End	0.47	Issue Type +	Ma	Location *	WS	
Category	Earthen Levee			GPS Latitude/Longitude		
				Start		End
Item	Vegetation			38.721297 °		°
				-121.808512 °		°
DWR ID	DWR_NA0021_01_s _ 2015_15					
Action/Comments						
Control annual grass and weeds on the levee slopes and easements.

View of vegetation on the waterward side of the levee looking downstream. Spring 2015.

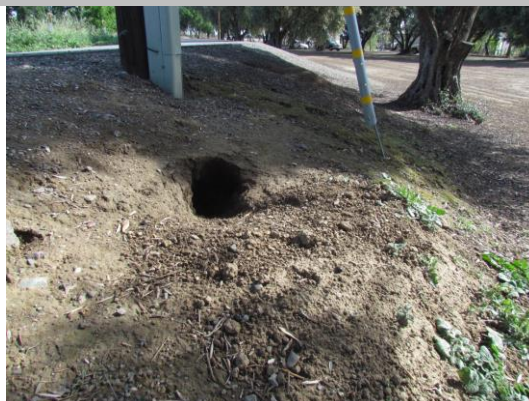
Photo 1 of 1 : SP_2015_NA0021_351_16_20150413_00020.jpg

LM Start	0.18	Rating **	U	Issue No.	16
LM End	0.22	Issue Type +	Ma	Location *	LS
Category	Earthen Levee			GPS Latitude/Longitude	
				Start	End
Item	Animal Control			38.721542 °	38.721918 °
				-121.807778 °	-121.807373 °
DWR ID	DWR_NA0021_01_s _ 2015_16				
Action/Comments					
Exterminate rodents and backfill and compact or grout burrows.

View of the rodent hole on the landward side of the levee looking downstream. Spring 2015.

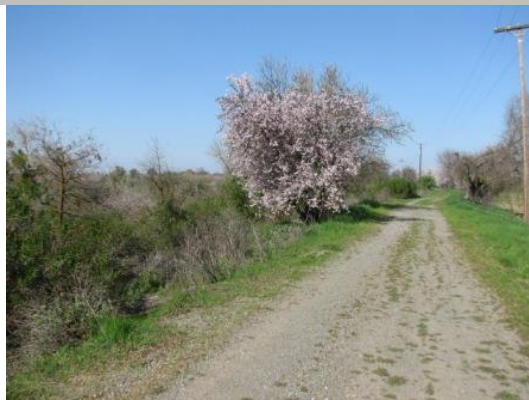
Photo 1 of 3 : SP_2015_NA0021_351_17_20150401_00014.jpg

LM Start	0.25	Rating **	U	Issue No.	17
LM End	0.50	Issue Type +	Ma	Location *	WS
Category	Earthen Levee			GPS Latitude/Longitude	
				Start	End
Item	Vegetation			38.722220 °	38.725887 °
				-121.806966 °	-121.806550 °
DWR ID	DWR_NA0021_01_s _ 2012_17				
Action/Comments					
Remove the wild growth other than native grasses from the levee slopes.

Vegetation and brush is taller than 12 inches. No visibility of the waterside berm. Spring 2013

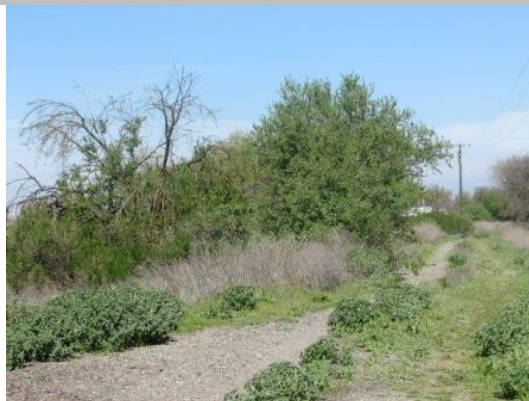
Photo 1 of 1 : SP_2015_NA0021_351_14_20150401_00013.jpg

LM Start	0.27	Rating **	A/W	Issue No.	14
LM End	0.27	Issue Type +	Ma	Location *	WS
Category	Earthen Levee			GPS Latitude/Longitude	
				Start	End
Item	Vegetation			38.722633 °	38.722633 °
				-121.806938 °	-121.806938 °
DWR ID	DWR_NA0021_01_s _ 2012_14				
Action/Comments					
Elderberries are blocking visibility and flood fight capability.

Photo taken spring 2012, a large Elderberry on the waterside.

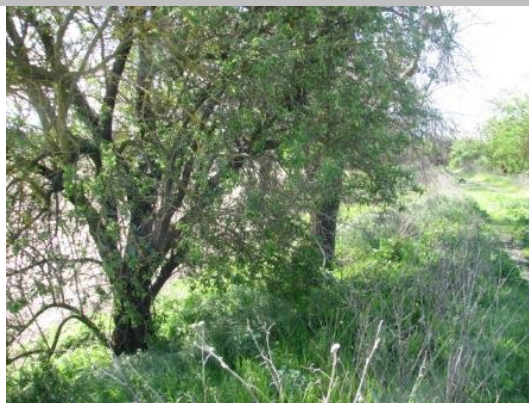
Photo 1 of 1 : SP_2015_NA0021_351_19_20150401_00017.jpg

LM Start	0.28	Rating **	M	Issue No.	19
LM End	0.30	Issue Type +	Ma	Location *	LS
Category	Earthen Levee			GPS Latitude/Longitude	
				Start	End
Item	Trim / Thin Trees			38.722699 °	38.723001 °
				-121.806920 °	-121.806864 °
DWR ID	DWR_NA0021_01_s _ 2012_19				
Action/Comments					
Trim and thin trees to allow visibility of the ground and room to flood fight.

The trees need to be thinned and trimmed up for visibility.

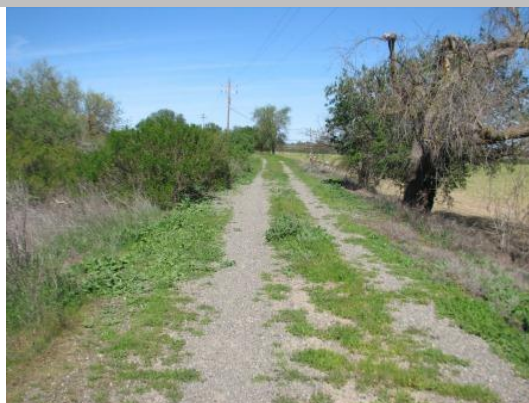
Photo 1 of 1 : SP_2015_NA0021_351_13_20150401_00012.jpg

LM Start	0.30	Rating **	M	Issue No.	13
LM End	0.50	Issue Type +	Ma	Location *	CR
Category	Earthen Levee			GPS Latitude/Longitude	
				Start	End
Item	Vegetation			38.723017 °	38.725844 °
				-121.806879 °	-121.806516 °
DWR ID	DWR_NA0021_01_s _ 2014_13				
Action/Comments					
Keep the crown roadway free of vegetation.

Vegetation on the crown needs to be controlled. Spring 2014

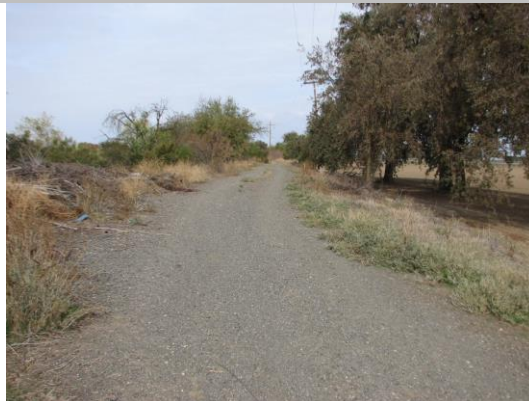
Photo 1 of 3 : SP_2015_NA0021_351_1_20150401_00002.jpg

LM Start	0.33	Rating **	M	Issue No.	1
LM End	0.50	Issue Type +	Ma	Location *	LS
Category	Earthen Levee			GPS Latitude/Longitude	
				Start	End
Item	Vegetation			38.723381 °	38.725835 °
				-121.806786 °	-121.806526 °
DWR ID	DWR_NA0021_01_s_2015_1				
Action/Comments					
Remove the wild growth other than native grasses from the levee slopes.					
Inspector Comments: This area now has been declared a habitat restoration area by the Cache Creek Conservancy.

Vegetation on levee slopes and crown. Fall 2014.

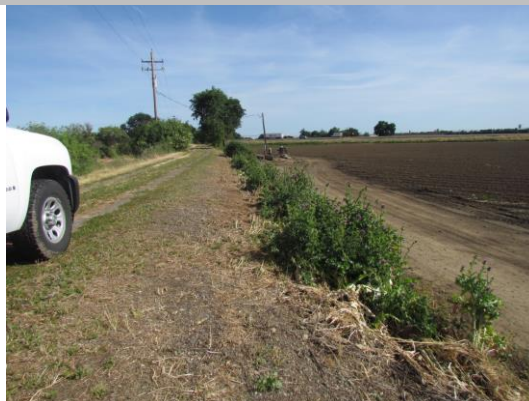
Photo 2 of 3 : SP_2015_NA0021_351_1_20150413_00022.jpg

View of vegetation on the landward side of the levee looking downstream. Spring 2015.

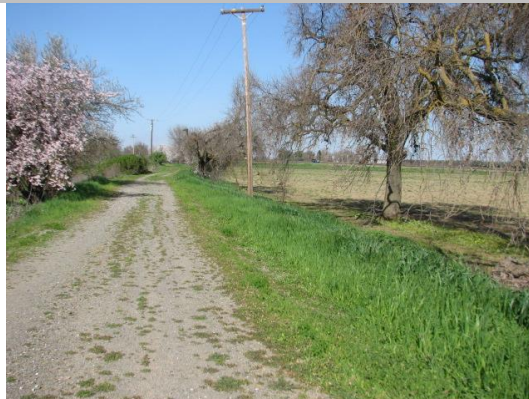
Photo 3 of 3 : SP_2015_NA0021_351_1_20150401_00003.jpg

Vegetation needs to be mowed taller than 12". Spring 2013

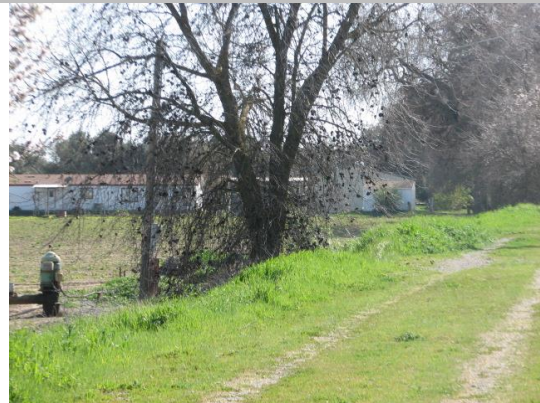
Photo 1 of 1 : SP_2015_NA0021_351_6_20150401_00007.jpg

LM Start	0.36	Rating **	M	Issue No.	6
LM End	0.36	Issue Type +	Ma	Location *	LS
Category	Earthen Levee			GPS Latitude/Longitude	
				Start	End
Item	Trim / Thin Trees			38.723903 °	38.723903 °
				-121.806613 °	-121.806613 °
DWR ID	DWR_NA0021_01_s _ 2012_6				
Action/Comments					
Trim trees to at least five feet above ground level.

Tree needs to be trimmed up 5'. Spring 2013

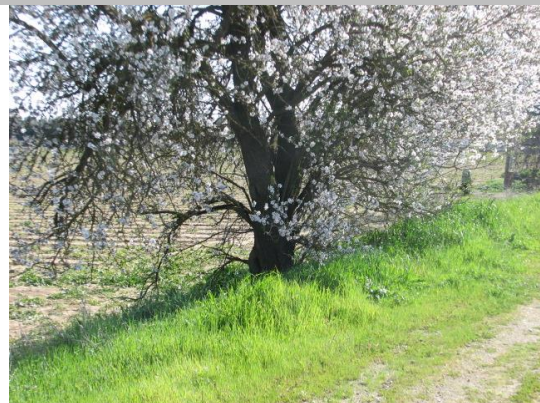
Photo 1 of 1 : SP_2015_NA0021_351_7_20150401_00008.jpg

LM Start	0.38	Rating **	M	Issue No.	7
LM End	0.38	Issue Type +	Ma	Location *	LS
Category	Earthen Levee			GPS Latitude/Longitude	
				Start	End
Item	Trim / Thin Trees			38.724165 °	38.724165 °
				-121.806552 °	-121.806552 °
DWR ID	DWR_NA0021_01_s _ 2012_7				
Action/Comments					
Trim trees to at least five feet above ground level.

Tree needs to be trimmed to 5'. Spring 2013

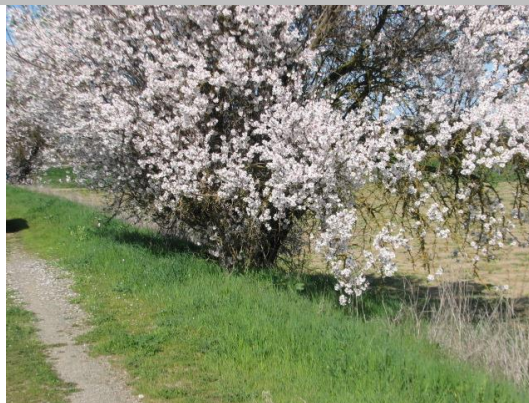
Photo 1 of 1 : SP_2015_NA0021_351_8_20150401_00009.jpg

LM Start	0.40	Rating **	M	Issue No.	8
LM End	0.40	Issue Type +	Ma	Location *	LS
Category	Earthen Levee			GPS Latitude/Longitude	
				Start	End
Item	Trim / Thin Trees			38.724445 °	38.724445 °
				-121.806505 °	-121.806505 °
DWR ID	DWR_NA0021_01_s _ 2012_8				
Action/Comments					
Trim trees to at least five feet above ground level.

Trees need to be trimmed to 5'. Spring 2013

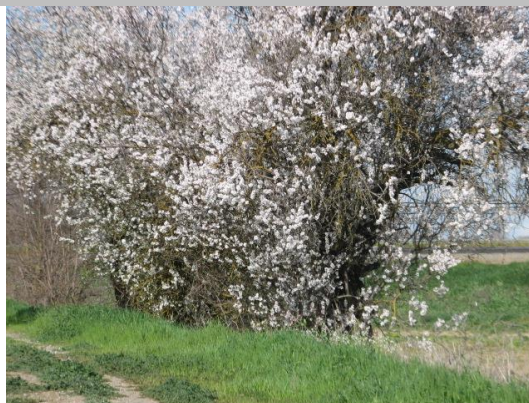
Photo 1 of 1 : SP_2015_NA0021_351_9_20150401_00010.jpg

LM Start	0.44	Rating **	M	Issue No.	9
LM End	0.44	Issue Type +	Ma	Location *	LS
Category	Earthen Levee			GPS Latitude/Longitude	
				Start	End
Item	Trim / Thin Trees			38.725022 °	38.725022 °
				-121.806478 °	-121.806478 °
DWR ID	DWR_NA0021_01_s _ 2012_9				
Action/Comments					
Trim trees to at least five feet above ground level.

Trees need to be trimmed to 5'. Spring 2013

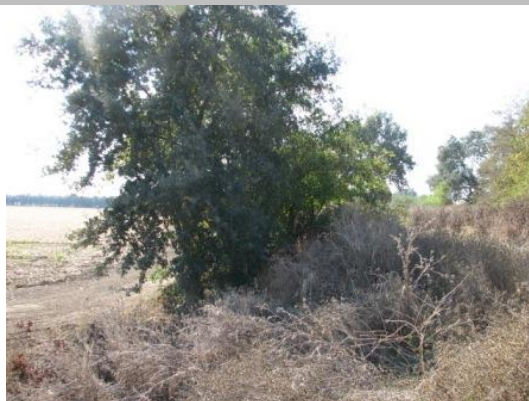
Photo 1 of 1 : SP_2015_NA0021_351_10_20150401_00011.jpg

LM Start	0.47	Rating **	M	Issue No.	10
LM End	0.47	Issue Type +	Ma	Location *	LS
Category	Earthen Levee			GPS Latitude/Longitude	
				Start	End
Item	Trim / Thin Trees			38.725427 °	38.725427 °
				-121.806470 °	-121.806470 °
DWR ID	DWR_NA0021_01_s _ 2012_10				
Action/Comments					
Trim trees to at least five feet above ground level.

The tree needs to be trimmed up. Photo taken fall of 2011.

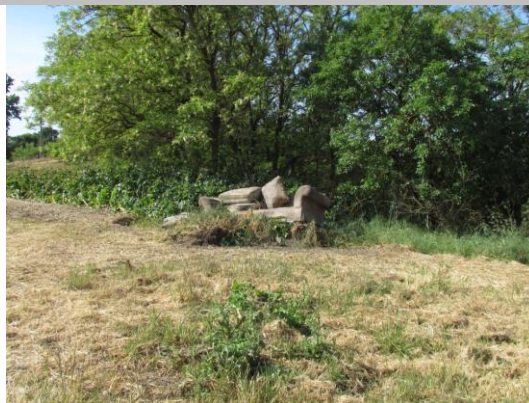
Photo 1 of 1 : SP_2015_NA0021_351_21_20150413_00023.jpg

LM Start	0.49	Rating **	M	Issue No.	21
LM End	0.49	Issue Type +	En	Location *	WS
Category	Earthen Levee			GPS Latitude/Longitude	
				Start	End
Item	Encroachments			38.725692 °	38.725692 °
				-121.806590 °	-121.806590 °
DWR ID	DWR_NA0021_01_s _ 2015_21				
Action/Comments					
Debris

View of a couch on the waterward side of the levee looking upstream.
Spring 2015.
